Annotated List of Properties

Ripley Town South – RC

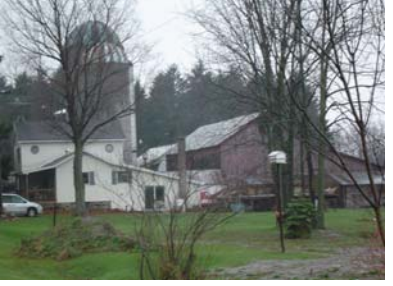
<p>Ripley; north side of Sherman Road; approx. 2250-ft. east of Sinden Road</p> <p>Date: ca. 1890-barn Condition: Good Alterations: Highly modified mid-late 20th c. farmhouse with vinyl siding, additions</p> <p>MAP FRAME: E3</p>	<p>This property is notable for its late 19th century barn, which is a gabled dairy barn with board and batten siding. It has sliding doors, the bank located on the south elevation, shed additions on the north side and a hay hood. The farm also has 2 concrete block silos, a harvestore, and 2 sheds.</p>	C

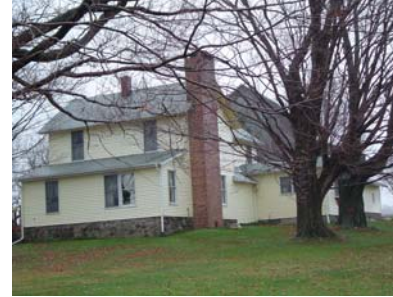
<p>4156 Sinden Road</p> <p>Date: ca. 1850 Condition: Good Alterations: Vinyl siding, windows</p> <p>MAP FRAME: E3</p>	<p>2-story, side-gabled, L-shaped, vernacular house with fieldstone foundation. This property is notable for its gambrel-roofed bank barn; see below.</p>	NC

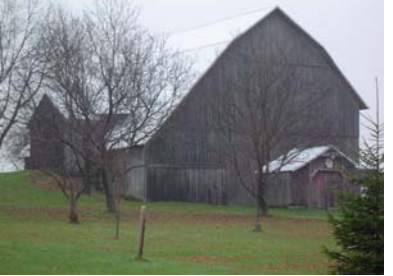
<p>4156A Sinden Road</p> <p>Date: ca. 1890 Condition: Excellent Alterations: Metal roof</p> <p>MAP FRAME: E3</p>	<p>Large, 2 ½- story, 3-bay bank barn with an asymmetrical gambrel roof, entry porch and barn bridge (filled in) on barn side. It has board and batten siding and a sliding wagon door entry on the gable end. Adjacent to the end gable is a wagon shed. An excellent, intact example of a gambrel bank barn with entry porch.</p>	S

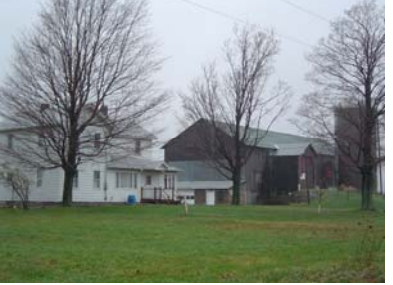
<p>Ripley; west side of Sinden Rd, approx. 390 ft. south of Sherman Rd.</p> <p>Date: ca. 1860 Condition: Good Alterations: Highly modified farmhouse.</p> <p>MAP FRAME: E3</p>	<p>This property is notable for its 1½ - story, side-gabled, 3-bay, bank barn with enclosed entry porch (ca.1880). It has a later concrete block foundation, at which time; the barn bridge may have been filled in. A shed addition with garage door entry bay on the end gable. 2 concrete block silos.</p>	House- NC Barn-S
