Annotated List of Properties

Ripley Village – RB

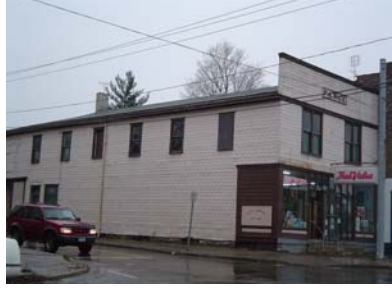
| Photo | Address/Date/ Condition/Alterations | Description | Rating: S,C,NC |
|---|---|---|---|
| | <p>Ripley (V); south side of West Main St (US 20) at corner of State St</p> <p>Date: ca. 1905 Condition: Good Alterations: Storefront modified</p> <p>Previously inventoried – No Determination</p> <p>MAP FRAME: C3 inset</p> | <p>2-story, commercial building with low, hipped-roof, false front, pressed metal siding replicating rock faced concrete block. Second floor windows are 2/2 and 1/1.</p> | <p>C</p> |

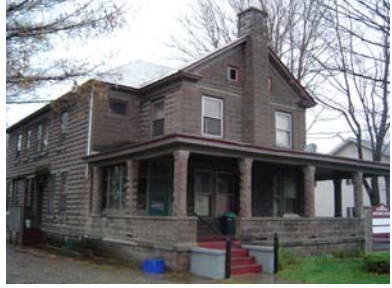
| Photo | Address/Date/ Condition/Alterations | Description | Rating: S,C,NC |
|---|---|---|---|
| | <p>63 West Main St.</p> <p>Date: ca. 1910 Condition: Good Alterations:</p> <p>MAP FRAME: C3 inset</p> | <p>2½ -story, hipped-roof, American Foursquare with rock-faced concrete block exterior. Currently used as an office building.</p> | <p>C</p> |

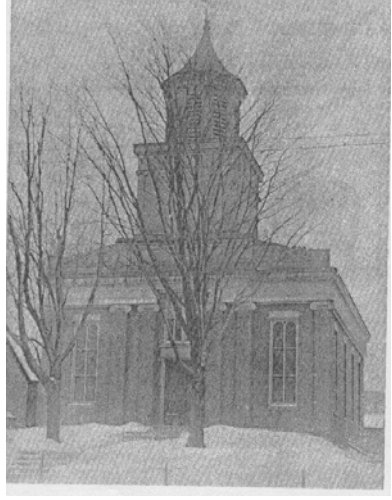
| Photo | Address/Date/ Condition/Alterations | Description | Rating: S,C,NC |
|---|---|---|---|
| | <p>First Presbyterian Church West Main St. (US 20)</p> <p>Date: 1853 Condition: Good Alterations:</p> <p>MAP FRAME: C3 inset</p> | <p>Greek Revival/Italianate style church, 3-by 4-bays, central square tower and louvered octagonal spire, engaged ionic columns. Paired narrow, round-arched windows with stained glass, stone lintels and sills, wide frieze, and parapet. (Cuurent photo not available - Historic photo from Ripley Sesquicentennial)</p> | <p>S</p> |

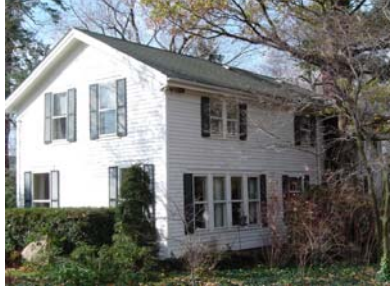
| Photo | Address/Date/ Condition/Alterations | Description | Rating: S,C,NC |
|---|--|--|---|
| | <p>95 West Main St. (US 20)</p> <p>Date: ca. 1850 Condition: Good Alterations: Windows</p> <p>MAP FRAME: C3 inset</p> | <p>1½-story, L-shaped, side-gabled, Greek Revival with clapboard, 1/1 windows.</p> | <p>C</p> |

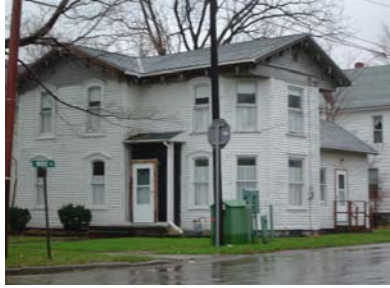
| Photo | Address/Date/ Condition/Alterations | Description | Rating: S,C,NC |
|---|--|--|---|
| | <p>96 West Main St. (US 20)</p> <p>Date: c. 1850 Condition: Good Alterations: Door</p> <p>MAP FRAME: C3 inset</p> | <p>2-story, gabled, L-shaped, Italianate house with roof brackets and segmental arch window hoods.</p> | <p>C</p> |

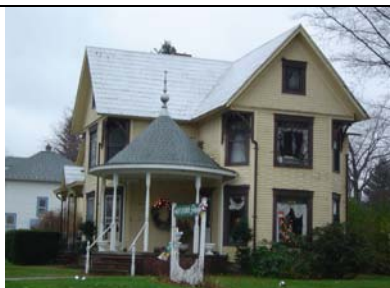
| Photo | Address/Date/ Condition/Alterations | Description | Rating: S,C,NC |
|---|--|--|---|
| | <p>98 West Main St. (US 20)</p> <p>Date: c. 1890 Condition: Good</p> <p>MAP FRAME: C3 inset</p> | <p>2½-story, L-shaped, Queen Anne house with round porch with conical roof and finial.</p> | <p>C</p> |

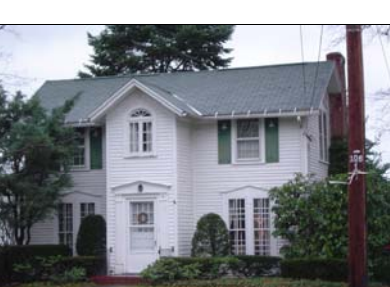
| Photo | Address/Date/ Condition/Alterations | Description | Rating: S,C,NC |
|---|--|--|---|
| | <p>99 West Main St. (US 20)</p> <p>Date: 1920s? Condition: Excellent Alterations:</p> <p>MAP FRAME: C3 inset</p> | <p>2-story, side-gabled, Colonial Revival house with 2- story pavilion.</p> | <p>C</p> |

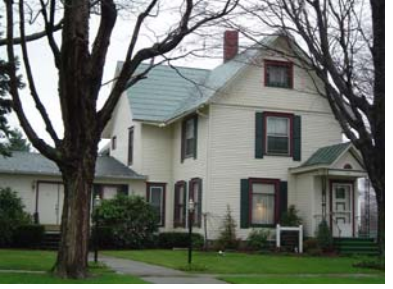
| Photo | Address/Date/ Condition/Alterations | Description | Rating: S,C,NC |
|---|--|--|---|
| | <p>104 West Main St. (US 20)</p> <p>Date: ca. 1890 Condition: Excellent Alterations: East wing, Porch supports and railings.</p> <p>MAP FRAME: C3 inset</p> | <p>2½ -story, cross-gabled, Queen Anne, sunburst design in pediment above front entrance. Converted for use as a funeral home.</p> | <p>C</p> |

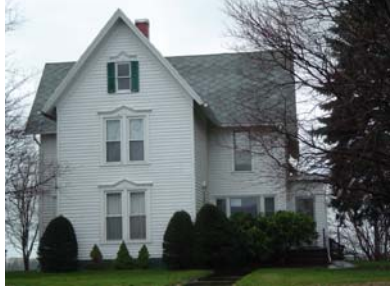
| Photo | Address/Date/ Condition/Alterations | Description | Rating: S,C,NC |
|---|---|--|---|
| | <p>123 West Main St. (US 20)</p> <p>Date: 1860 Condition: Good Alterations: Entry porch</p> <p>MAP FRAME: C3 inset</p> | <p>1½ -story, cross-gabled, Gothic Revival house with pointed arch hoods.</p> | <p>C</p> |

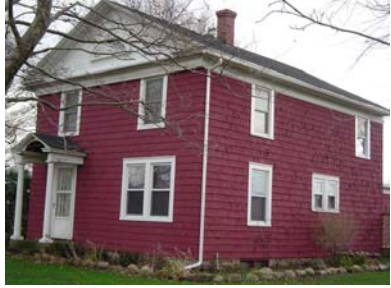
| Photo | Address/Date/ Condition/Alterations | Description | Rating: S,C,NC |
|---|---|--|---|
| | <p>10247 US Rte 20</p> <p>Date: ca. 1830 Condition: Good Alterations: Windows, Rear flat addition, Colonial Revival entry porch</p> <p>MAP FRAME: C2</p> | <p>2-story, closed-gabled, Federal/Greek transitional house with wood shingle, wide frieze, louvered fan light with keystone in gable end.</p> | <p>C</p> |
