HISTORIC RESOURCE INVENTORY FORM

Study: City of Buffalo Intensive Level Historic Resources Survey: Broadway-Fillmore Neighborhood

Prepared by: Clinton Brown Company Architecture, pc Address: 2100 Rand Building, 14 Lafayette Sq., Buffalo NY 14203

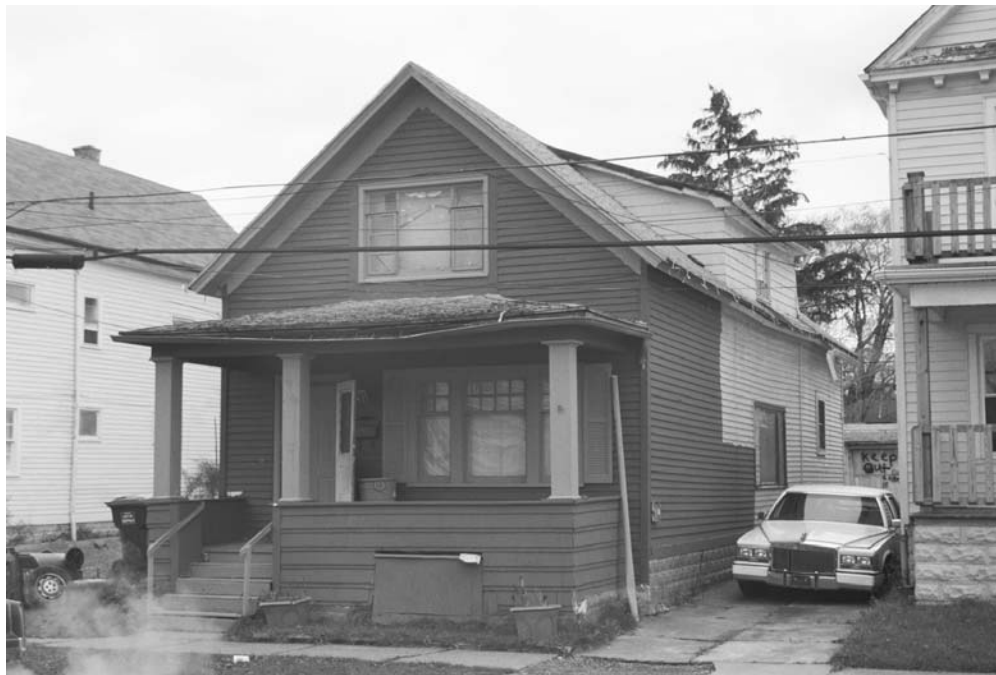
PHOTOGRAPH: (Broadway-Fillmore R-6; N-8)

A one-and-one-half story, frame, extended- workers' cottage with a broad front-gabled roof. It has a rectangular plan and no foundation. The façade has a full-width Craftsman porch with square columns and wood-shingled solid rail. The first floor façade has a main entrance in the east bay and a Craftsman-type, triple window-grouping. Exterior wall fabrics are wood shingle and clapboard. Fenestration is one-over-one, double-hung wood sash and casement. The west slope has a shed dormer. A brick chimney rests on the rear ridge. A single-bay garage stands at the southwest corner of the lot.

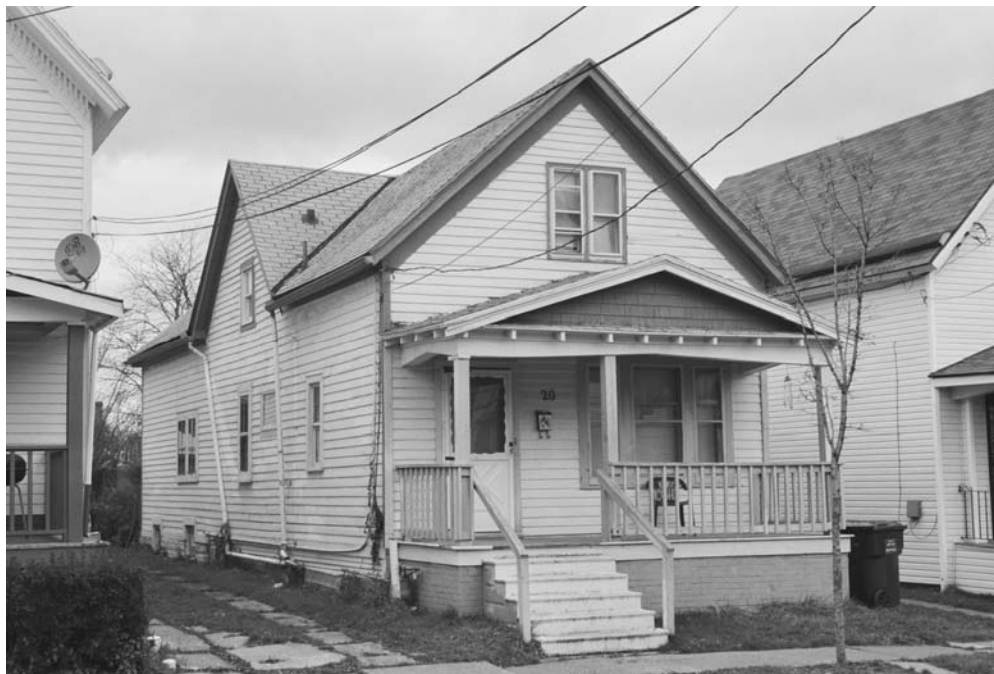
PHOTOGRAPH: (Broadway-Fillmore R-6; N-9)

A one-and-one-half story, frame workers' cottage with a front-gabled roof. It has a rectangular plan and no foundation. The façade has a full-width Craftsman-detailed porch that includes square columns, a gabled roof with wood-shingles and exposed rafter tail ends. The first floor façade has a main entrance in the west bay and a triple-window grouping in the east bay. Exterior wall fabrics are wood shingle and clapboard. Fenestration is one-over-one, double-hung wood sash. The west elevation has a gabled wall dormer. A brick chimney rests on the rear ridge.

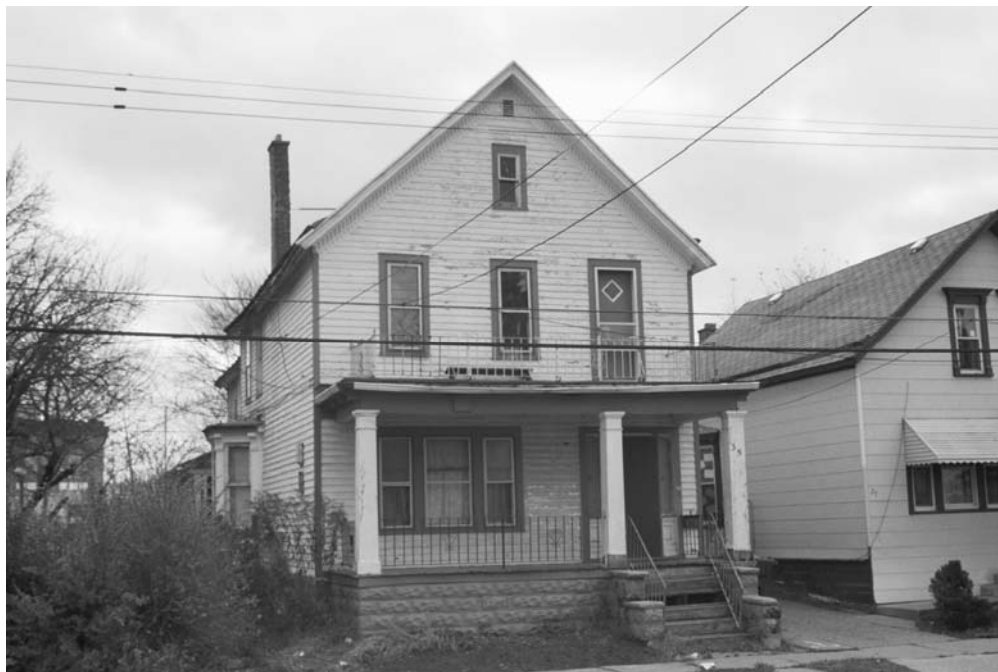
PHOTOGRAPH: (Broadway-Fillmore R-6; N-10)

A two-and-one-half story, front-gabled, frame, vernacular residence with no foundation. It has a rectangular plan. Exterior wall fabric is clapboard. The façade has a full-width porch with square columns, a metal rail, and an ornamental concrete block foundation. The entrance with $\frac{3}{4}$ sidelights is located in the west bay. Fenestration is one-over-one, double-hung wood sash. The upper façade has an open porch with metal balustrade and an entry door in the west bay. A small one-over-one double-hung sash window punctuates the gable peak. Other architectural details include Eastlake molding beneath the front gable eaves, and a polygonal bay with brackets on the east elevation. A brick chimney rests on east slope.

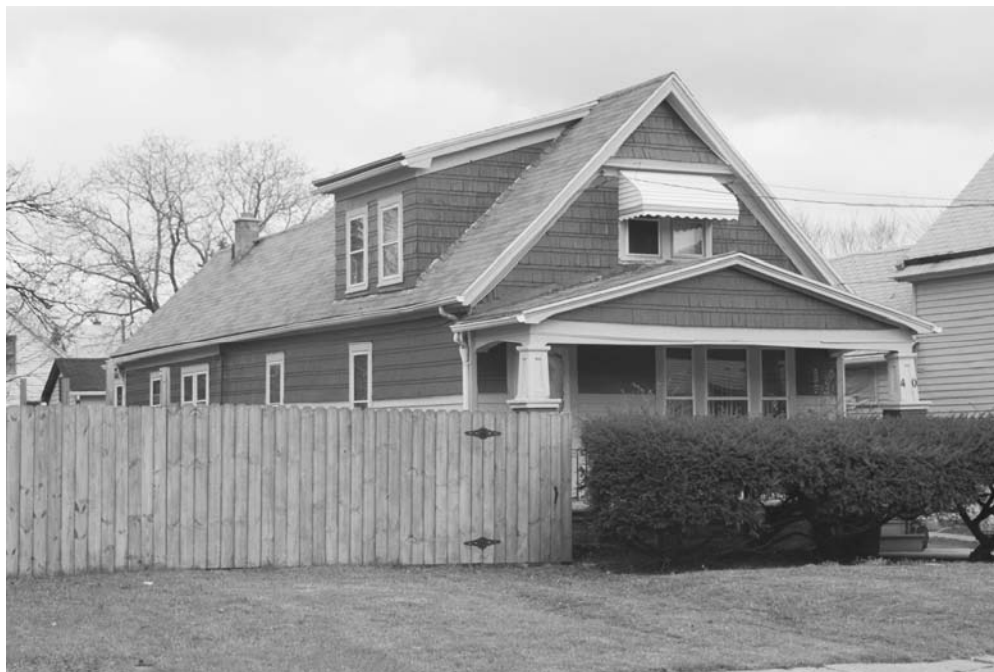
PHOTOGRAPH: (Broadway-Fillmore R-6; N-11)

A one-and-one-half story, frame workers' cottage with a broad front-gabled roof. It has a rectangular plan and no foundation. The façade has a full-width, Craftsman porch with battered, square, paneled piers set on square, wood-shingled pedestals, and a gabled-roof with wood shingles. The original porch rail has been replaced. The main entrance is in the west bay. Exterior wall fabrics are wood shingle and clapboard. Fenestration is one-over-one, double-hung wood sash and casement. The gable end has a paired window grouping with pent. The east slope has a shed dormer. A brick chimney is located rear, off-center ridge.

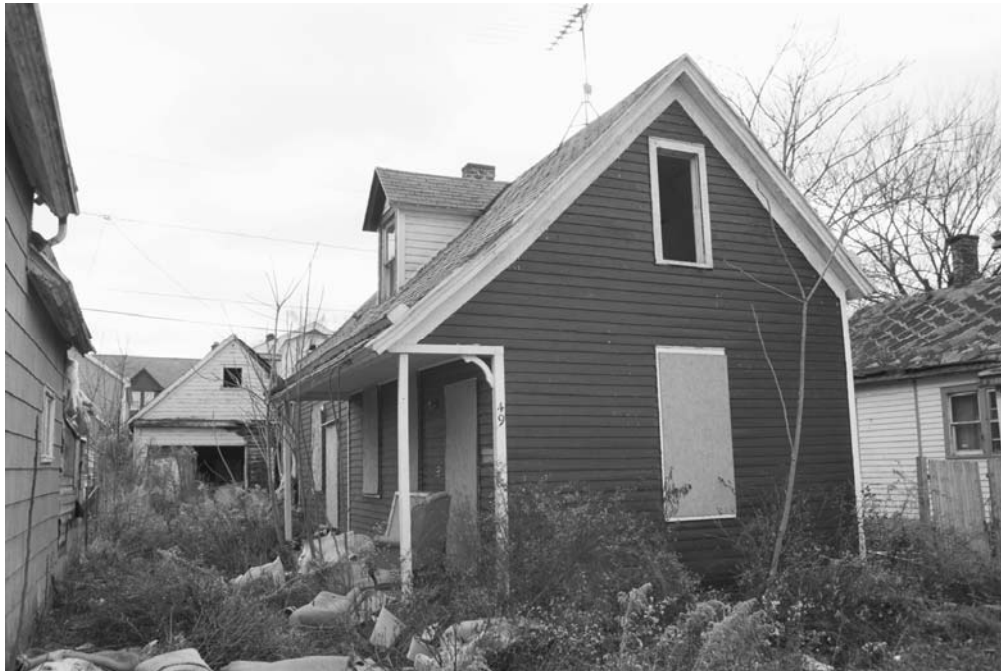
PHOTOGRAPH: (Broadway-Fillmore R-6; N-13)

A one-and-one-half story, front-gabled, workers' cottage with no foundation. It has a rectangular plan. The main entrance and porch are located on the east elevation of the one-bay-wide cottage. The house appears not to have been completed, as it is comprised of only the rear section of what resembles the extended cottage. Exterior wall fabric is clapboard. The window openings have been boarded. A gabled-dormer rests on the east slope and brick chimney is located rear ridge. A single- bay, front-gabled garage sheathed with clapboard stands at the southeast corner of the lot.

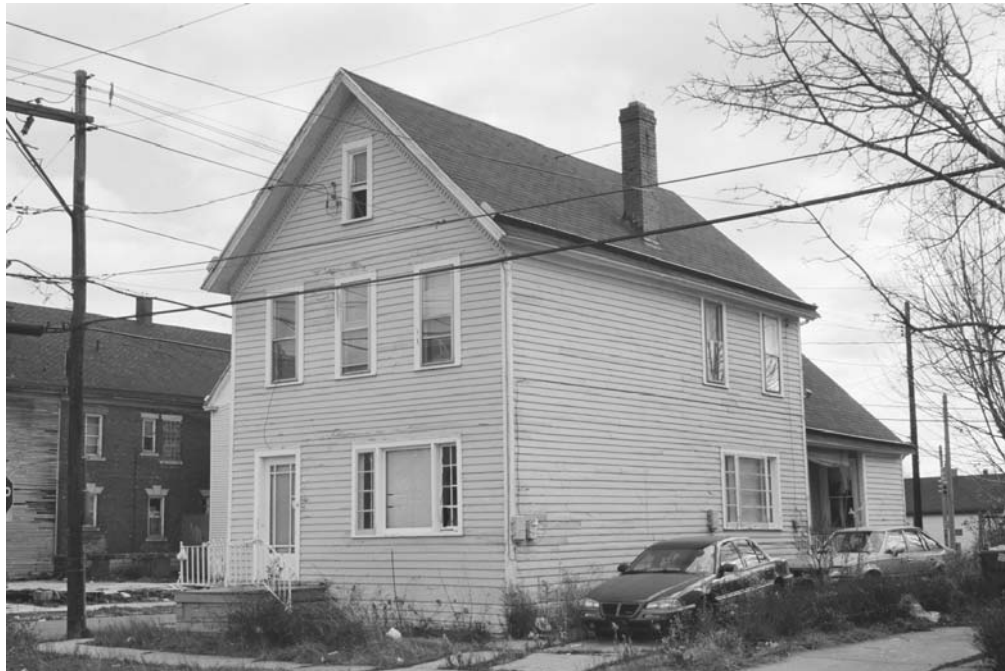
PHOTOGRAPH: (Broadway-Fillmore R-6; N-15)

A two-and-one half story, front-gabled, frame, vernacular residence with no foundation. It has a rectangular plan and no basement. Exterior wall fabric is clapboard. The façade has an entrance with modern stoop in the east bay. Fenestration is one-over-one, double-hung wood sash and casement. Other architectural details include corner boards and Eastlake molding. A one-story addition with recessed entry porch extends south from the south end of the main block. A brick chimney rests on the west slope.

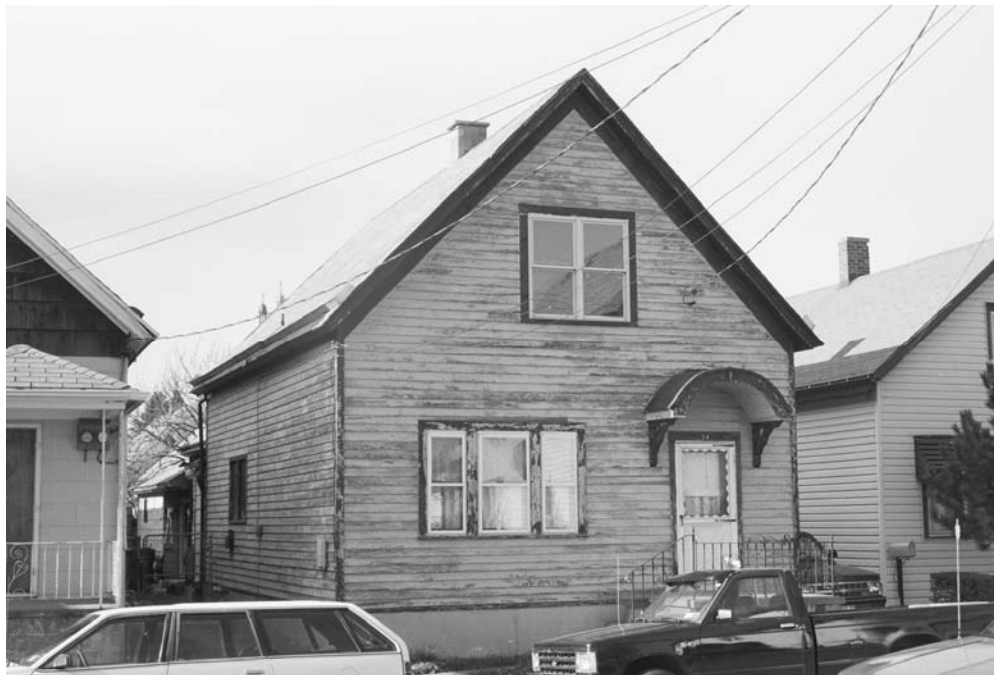
PHOTOGRAPH: (Broadway-Fillmore R-11; N-12)

A one-and-one-half story, front-gabled, frame, extended workers' cottage with no foundation. It has a rectangular plan. The façade has an entry door with a bracketed canopy and a modern stoop located in the north bay. Exterior wall fabric is clapboard. Fenestration is one-over-one, double-hung wood sash. Extending west from the west end of the main block are two one-story, gabled-roof additions. A brick chimney rests on the center ridge of the main block and rear additions.

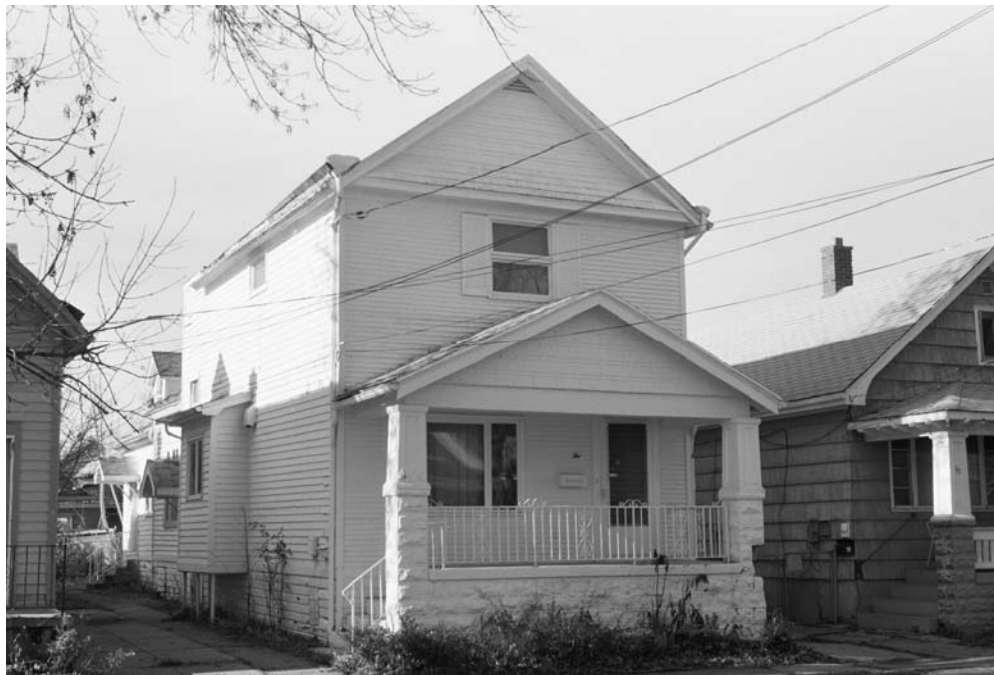
PHOTOGRAPH: (Broadway-Fillmore R-11; N-11)

A two-story, closed-gabled, frame, extended workers' cottage with no foundation. It has a rectangular plan. The façade has Craftsman-detailed full-width porch with a rusticated block foundation, battered, square, paneled supports and a wood-shingled pediment. The original porch rail has been replaced. The main entrance is located in the north bay. Exterior wall fabrics are clapboard and wood shingle. Fenestration is casement and one-over-one, double-hung wood sash. An oriel is located on the south side. Extending west from the west end of the main block are two one-story, gabled-roof additions with entries and gabled dormers on the south elevation. A brick chimney rests on the center ridge of the main block and rear additions.

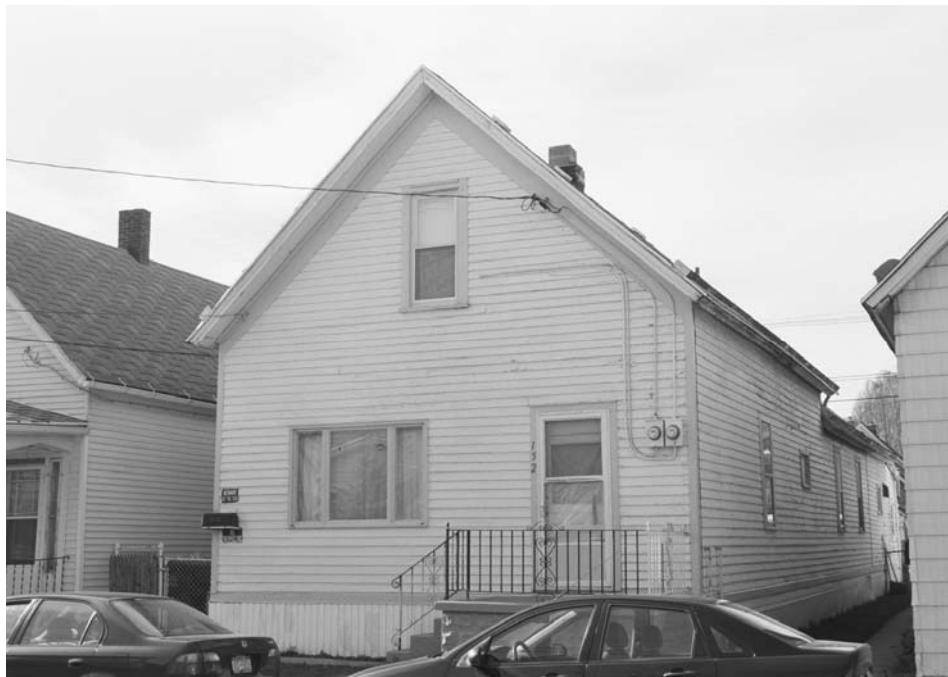
PHOTOGRAPH: (Broadway-Fillmore R-11; N-10)

A one-and-one-half story, front-gabled, frame, extended workers' cottage with no foundation. It has a rectangular plan. The façade has an entry door and a modern stoop located in the north bay. Exterior wall fabric is clapboard. Fenestration is one-over-one, double-hung wood sash. Extending west from the west end of the main block are two one-story, gabled-roof additions with side entrances. A brick chimney rests on the center ridge of the main block and rear additions.

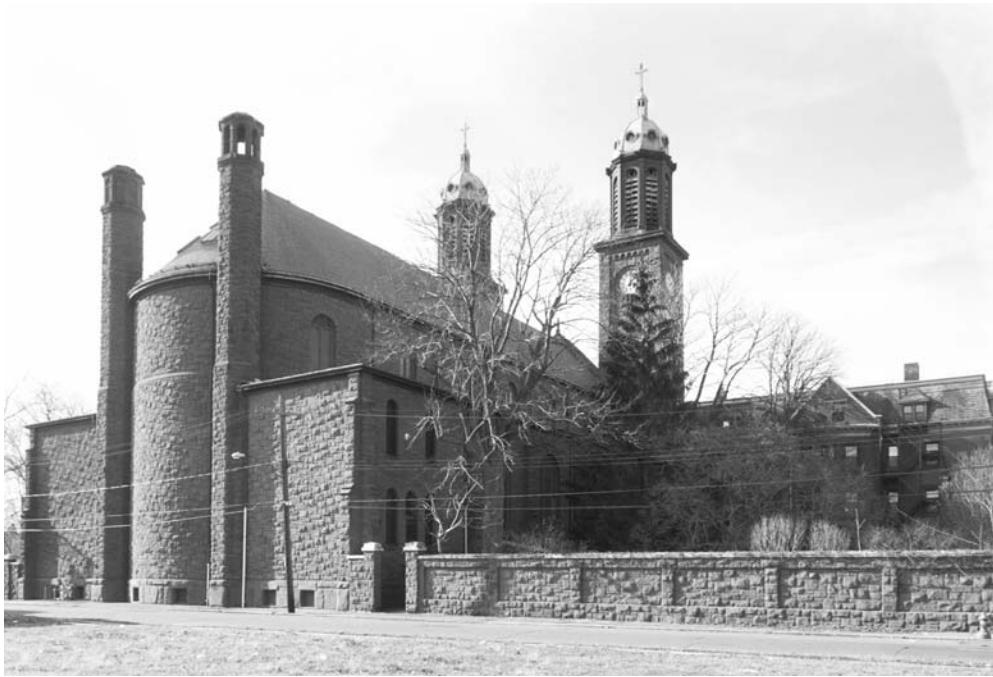
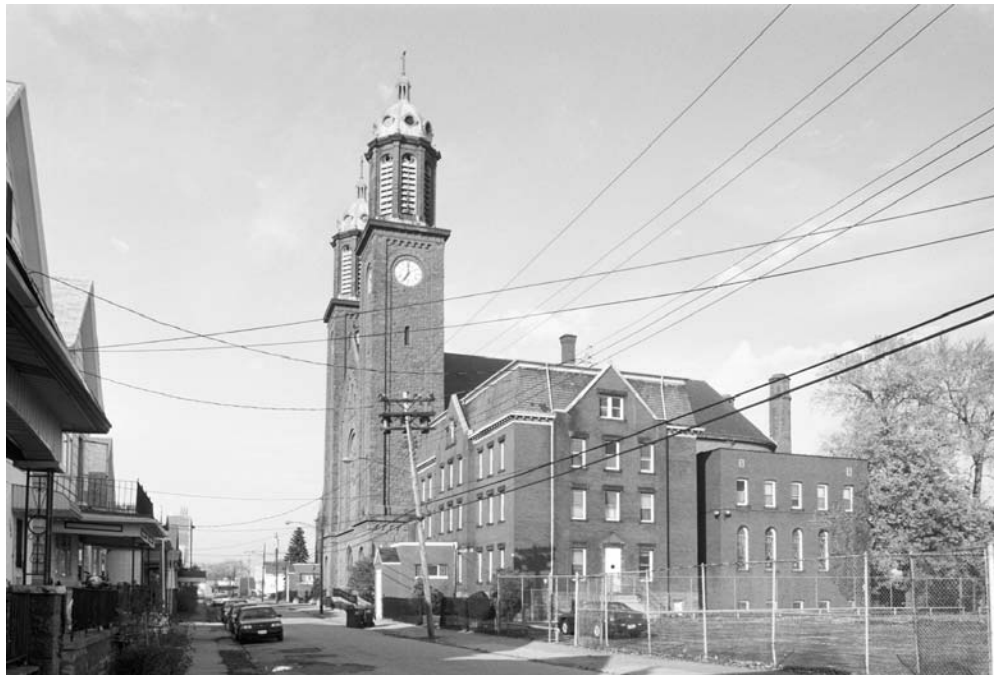
PHOTOGRAPH: (Broadway-Fillmore R-2; N-11, 12, 22)

A twin-towered, Romanesque style church constructed of rusticated red Medina sandstone. It has a rectangular plan that measures 90-ft wide and 175-ft-deep. The imposing square towers rise to a height of 175-ft, the nave stands at a height of 90-ft, and the side aisles are 40-ft high. Heavy, coursed quarry-faced ashlar masonry distinguishes the ground floor from the random, quarry faced masonry of the upper portion of the church. The west façade has round-arched portals in the nave and towers. Each portal features double-leaf paneled doors and a tympanum with stained glass. The nave portal features a foliated compound arch in the door surround, Romanesque capitals, and a quatrefoil in the tympanum. A blind arcade accents the ground floor and gable. The façade features a rose window with a center quatrefoil and stone tracery. A triple window grouping of small round-arched windows punctuates the gable end. The upper zones of the square towers feature a clock in each elevation. The octagonal-shaped belfries have coursed dressed ashlar masonry, louvered openings, and copper sheathed cupolas punctuated by an oculus in each side.

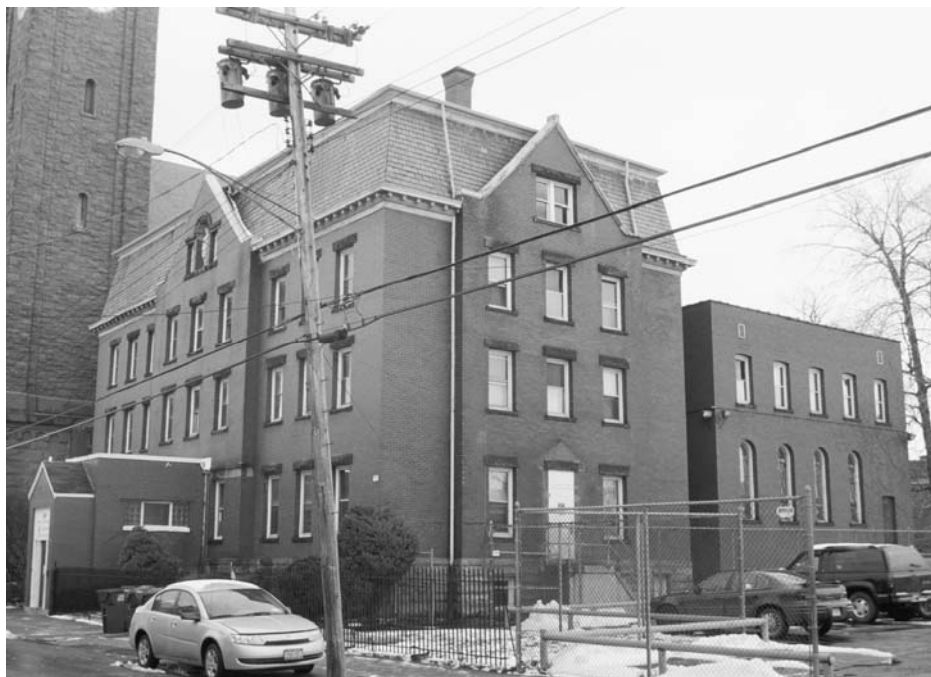
PHOTOGRAPH: (Broadway-Fillmore R-15; N-32)

A three-and-one-half story, brick masonry building with a Mansard roof. The main section is a rectangular block that is nine-bays-wide and three-bays-deep and is set on a raised, limestone foundation. The west façade and south elevation have full-height, projecting bays with pediment. The original main entrance has been altered by the addition of a vestibule. Fenestration is symmetrical with one-over-one double-hung sash, and sandstone sills and lintels. The roofline is accented by a cornice with dentil course. A two-story, brick masonry Chapel is attached to the east elevation of the convent. The first floor has tall narrow, round-arched window openings with stained glass.

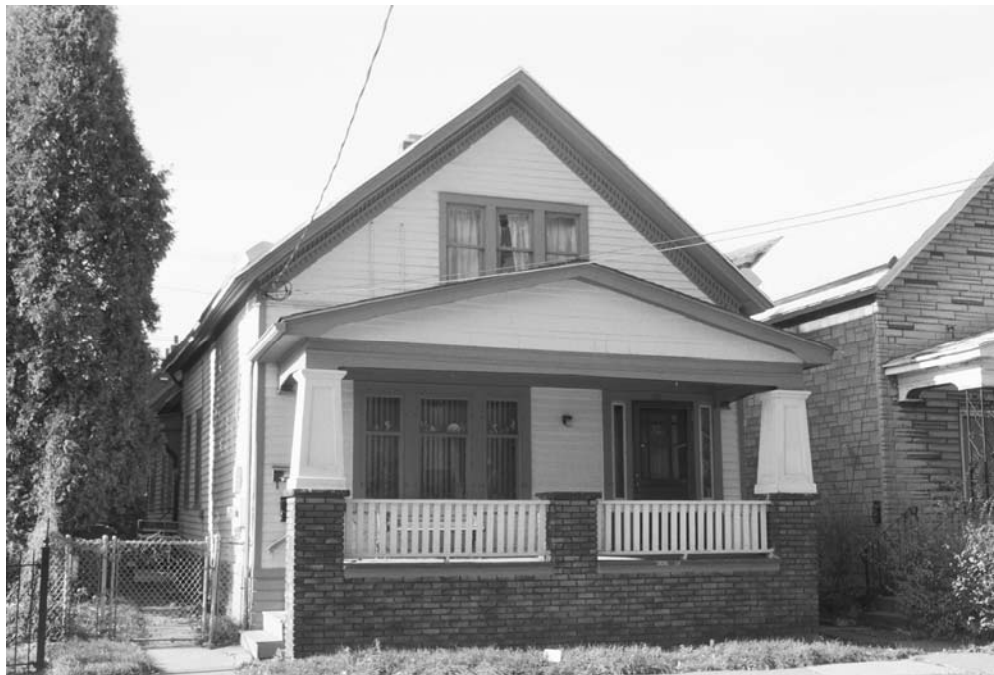
PHOTOGRAPH: (Broadway-Fillmore R-11; N-9)

A one-and-one half-story, frame, front-gabled extended workers' cottage with no foundation. It has a rectangular plan and no basement. The façade has Craftsman-detailed full-width porch with a brick foundation and pedestals, battered, square, paneled supports and a wood-shingled pediment. The main entrance with sidelights is located in the north bay. Exterior wall fabrics are clapboard and wood shingle. Fenestration is casement and one-over-one, double-hung wood sash. Eastlake molding accents the gable end. Extending west from the west end of the main block are two one-story, gabled-roof additions with entries and gabled dormers on the south elevation. A brick chimney rests on the center ridge of the main block and rear additions.
