HISTORIC RESOURCE INVENTORY FORM

Study: City of Buffalo Intensive Level Historic Resources Survey: Broadway-Fillmore Neighborhood

Prepared by: Clinton Brown Company Architecture, pc Address: 2100 Rand Building, 14 Lafayette Sq., Buffalo NY 14203

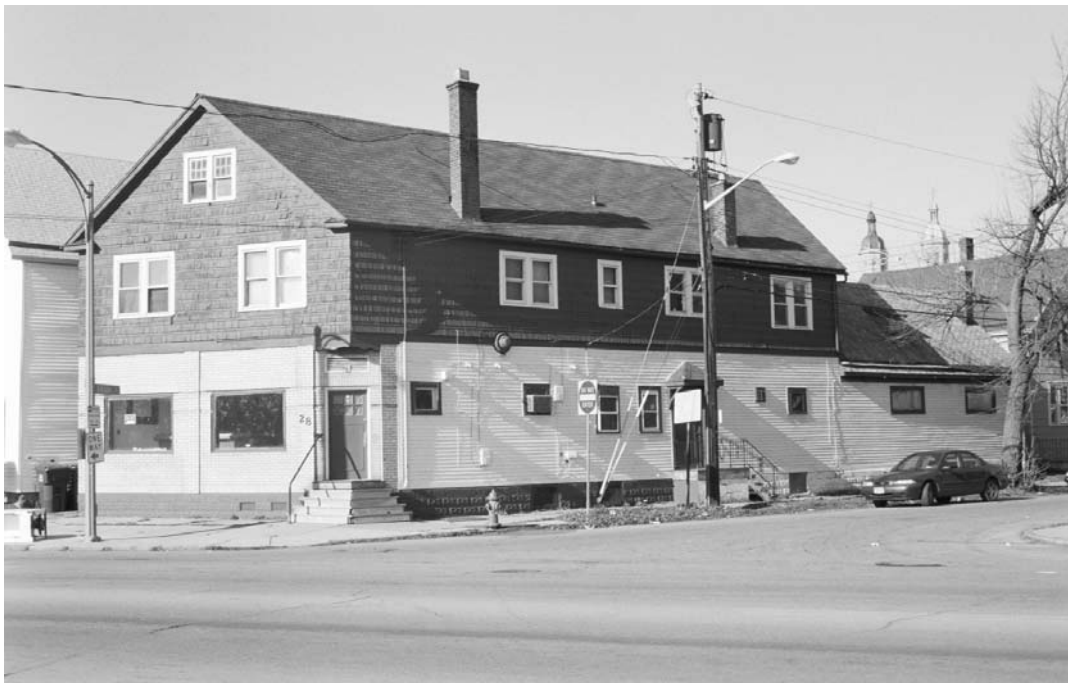
PHOTOGRAPH: (Broadway-Fillmore R-10; N-25)

A two-and-one-half-story, front-gabled mixed-use building. It has a rectangular plan and is set on a rusticated concrete block foundation. The brick commercial front has a corner entrance bay with stoop, and large fixed display windows. Exterior wall fabrics are clapboard on the first floor and wood shingles on the upper level. Fenestration is paired, one-over-one double-hung wood sash. The gable end features cornice returns and a paired window grouping of six-over one, double-hung wood sash. A side entrance with bracketed hood is located on the east elevation. A one-story, gabled-roof addition extends north from the north end of the main block. Two brick chimneys rest on the east slope and one is located on the east slope of the rear addition.

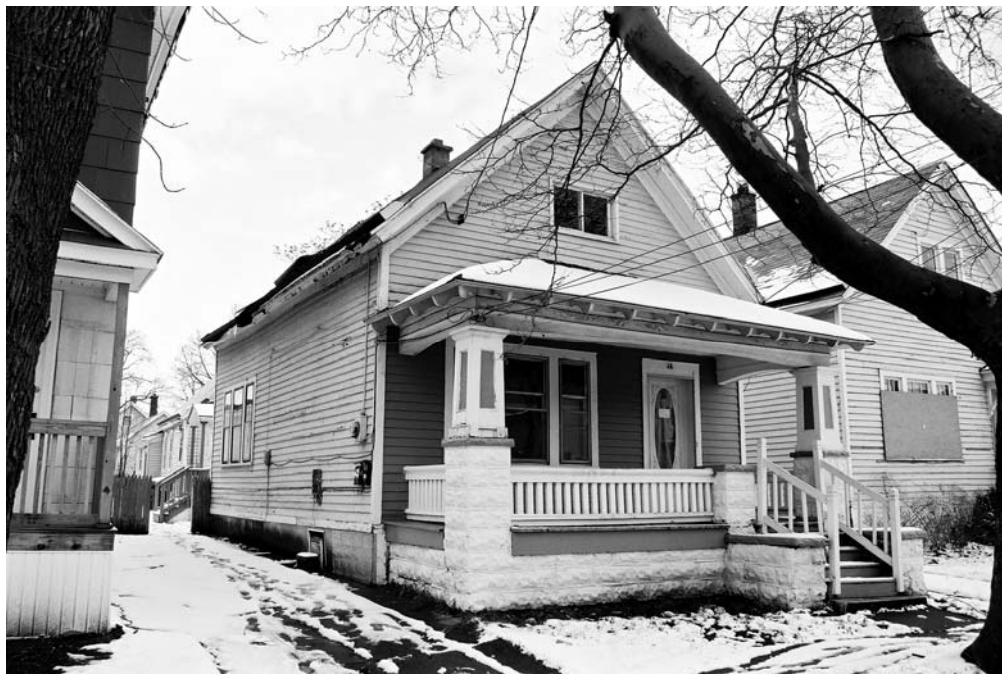
PHOTOGRAPH: (Broadway-Fillmore R-14; N-10)

A one-story, front-gabled, frame workers' cottage with no foundation. It has a rectangular plan. The façade has a full-width, Craftsman-detailed porch with rusticated concrete block and pedestals, square, paneled piers, and open wooden rail, and a hipped roof with exposed rafter tail ends. The main entrance is in the north bay and a triple window grouping is set in the south bay. Exterior wall fabric is clapboard. Fenestration is one-over-one, double-hung wood sash. A brick chimney rests on the center ridge of main block. A one-story addition extends west from the west end of the main block.

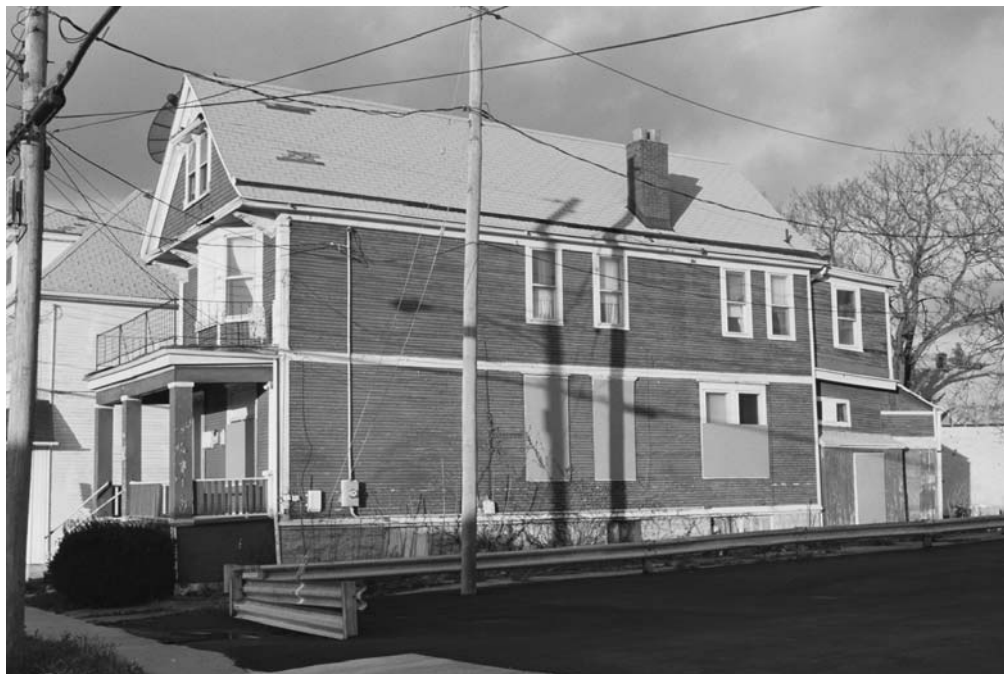
PHOTOGRAPH: (Broadway-Fillmore R-7; N-12)

A two-and-one-half story, closed-gabled residence with Craftsman detailing. It has a rectangular plan and is set on a rough-cut, limestone block foundation. Fenestration is one-over-one-double-hung wood sash. Exterior fabrics are clapboard and wood shingle. The façade has a full-width porch with square columns and an open wooden rail. The entrance door is located in the north bay. The second floor façade has an open porch with replacement balustrade and an oriel in the south bay. The overhanging gable features brackets and a paired window grouping with pent. Other elements include corner boards and beltcourses. A brick chimney rests on the south slope. A two-story addition extends east from the east end of the main block. The house is currently vacant and the windows on the ground floor are boarded.

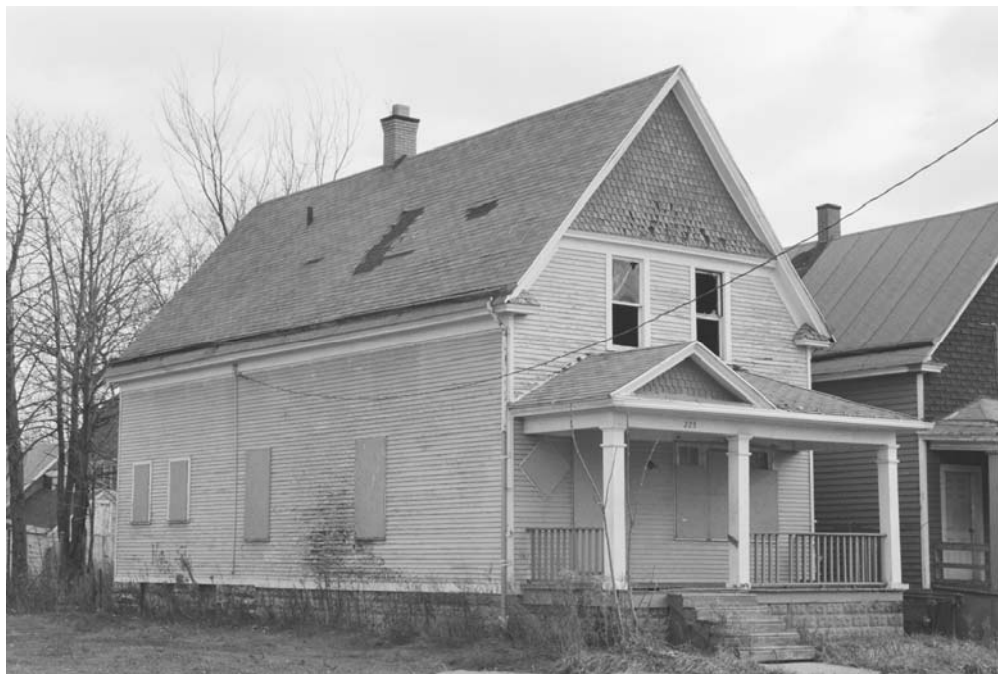
PHOTOGRAPH: (Broadway-Fillmore R-6; N-16)

A one-and-one-half story, frame workers' cottage with a steeply-pitched front-gabled roof. It has a rectangular plan and is set on a rusticated concrete block foundation. The façade has a full-width Craftsman-detailed porch that includes square columns, a replacement open rail and a pediment above the entrance. The main entrance is in the north bay. Exterior wall fabrics are clapboard and wood shingle. The ground floor window and door openings are presently boarded. Fenestration in the gable end is one-over-one, double-hung wood sash. A brick chimney rests on the center ridge.

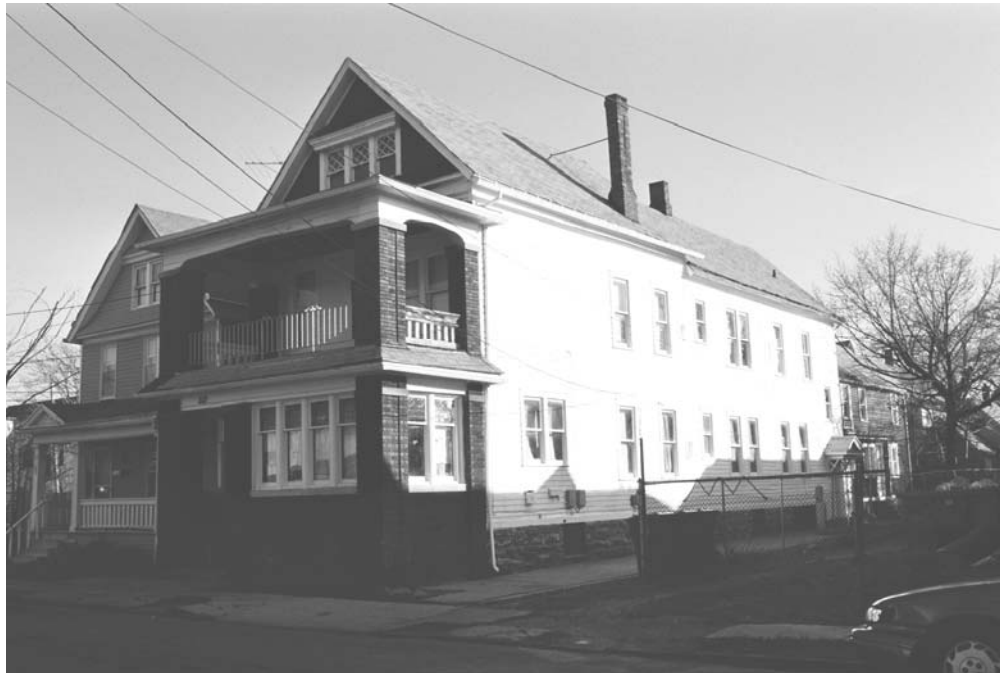
PHOTOGRAPH: (Broadway-Fillmore R-7; N-19)

A two-and-one-half story, closed-gabled residence with Craftsman detailing. It has a rectangular plan and is set on a limestone block foundation. The façade has tiered brick porches; the ground floor contains a cutaway porch in the north bay and a living porch with leaded glass headers. The upper porch has an open wooden rail and square corner piers supporting a flat roof. Fenestration is symmetrical with one-over-one-double-hung wood sash. Exterior fabric is clapboard. The gable end has a triple window grouping with diamond pattern in the upper sash capped by a pent. A brick chimney rests on the south slope. A two story addition with entrance on the south elevation extends east from the east end of the main block. A detached, front-gabled, one-and one-half- story cottage sheathed with clapboard stands on the northeastern corner of the lot.

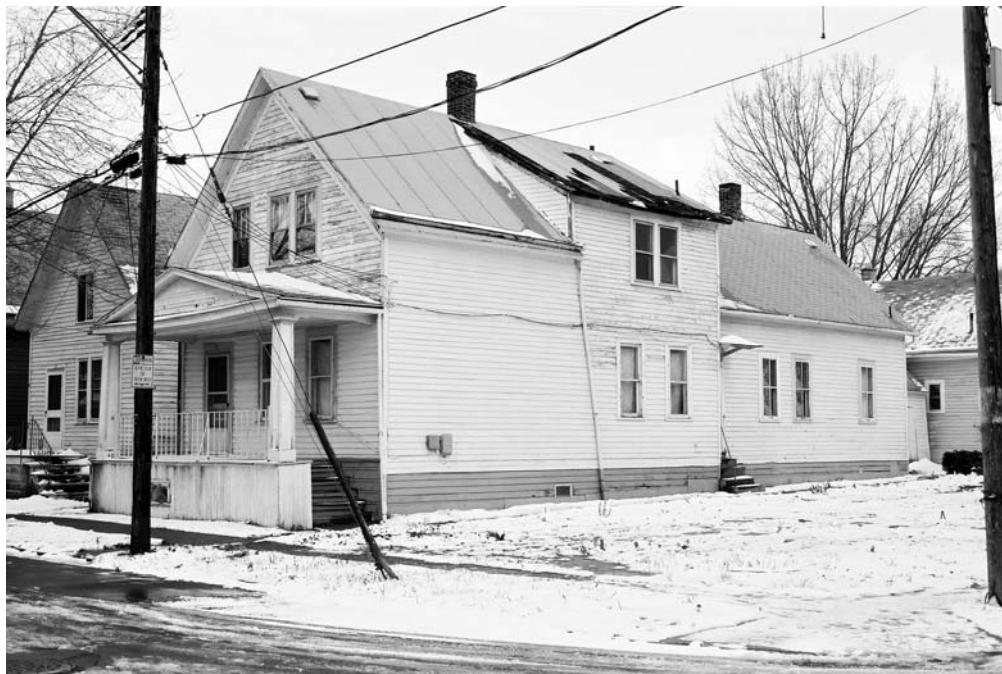
PHOTOGRAPH: (Broadway-Fillmore R-14; N-13)

A one-and-one-half story, front-gabled, frame, extended workers' cottage with no foundation. It has a rectangular plan. The façade has a full-width Craftsman porch with paneled, square columns, a replacement metal rail and a wood-shingled pediment. The entry door is located in the north bay. Window and door openings of the lower façade feature Eastlake surrounds. Exterior wall fabric is clapboard. Fenestration is three- and one-over-one, double-hung wood sash. Eastlake molding accents the gable end. The south slope has a shed wall dormer. Extending east from the east end of the main block is a one-story, gabled-roof addition. A brick chimney rests on the center ridge of the main block and rear addition.

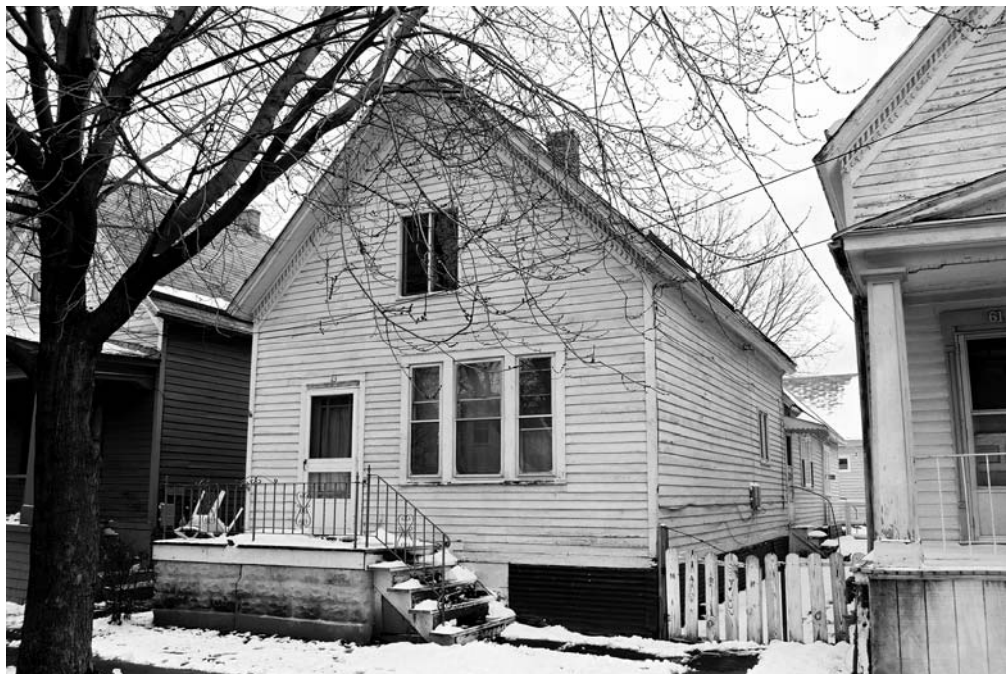
PHOTOGRAPH: (Broadway-Fillmore R-14; N-14)

A one-and-one-half story, front-gabled, frame, extended workers' cottage with no foundation. It has a rectangular plan. The façade has an entry door with a rusticated concrete block entry porch with stoop in the north bay and a triple window grouping in the south bay. Exterior wall fabric is clapboard. Fenestration is one-over-one, double-hung wood sash. Eastlake molding accents the gable end. Extending east from the east end of the main block are two one-story, gabled-roof additions. The larger rear addition has an entrance on the south elevation. A brick chimney rests on the center ridge of the main block.

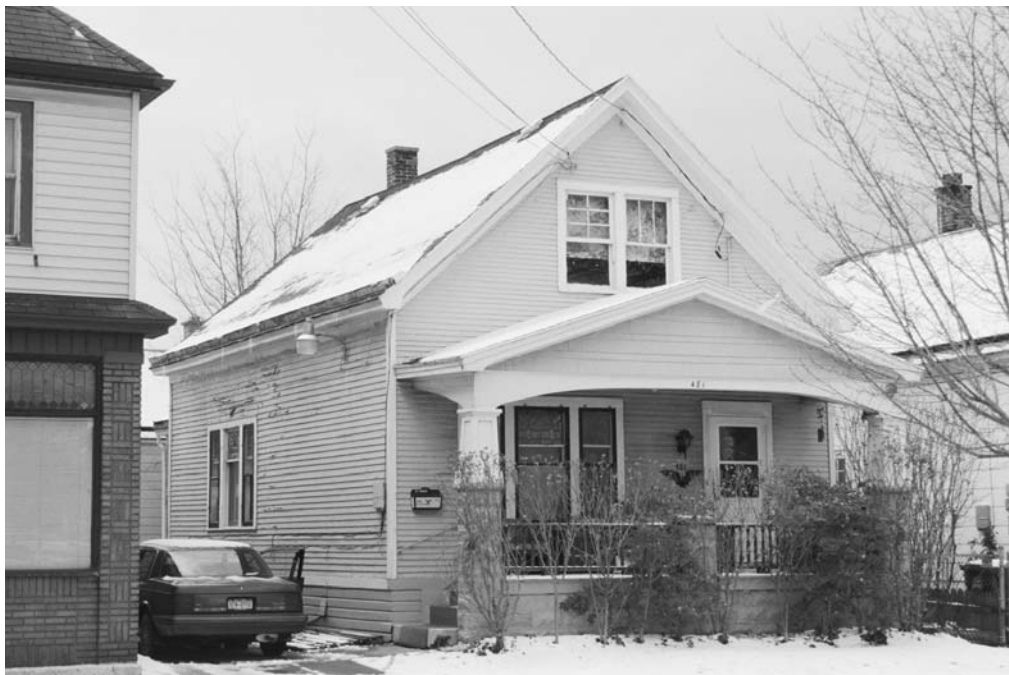
PHOTOGRAPH: (Broadway-Fillmore R-15; N-2)

A one-and-one-half story, front-gabled, frame, extended workers' cottage with no foundation. It has a rectangular plan. The façade has a full-width porch with square columns, a replacement metal rail and a pediment in the west bay above the entry. Exterior wall fabric is clapboard. Fenestration is one-over-one, double-hung wood sash and casement. The gable end features an oriel capped by a gable with brackets. Extending north from the east north end of the main block are two one-story, gabled-roof additions. A brick chimney rests on the center ridge of the main block and rear additions.

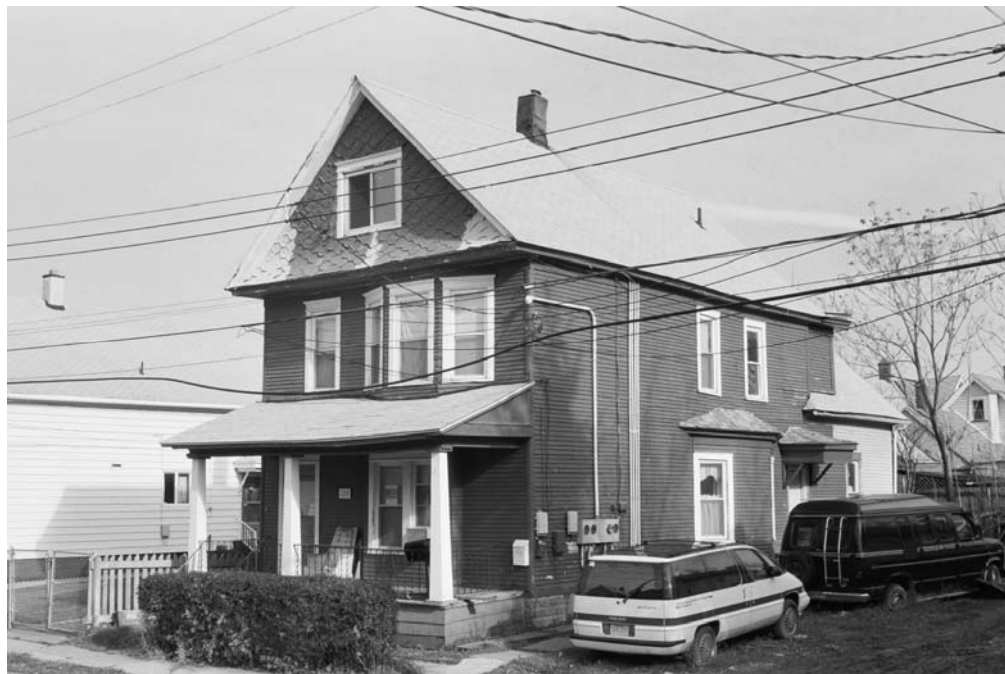
PHOTOGRAPH: (Broadway-Fillmore R-11 N-23)

A one-and-one-half story, front-gabled, frame, Craftsman workers' cottage. It has a rectangular plan and is set on a rusticated concrete block foundation. The façade has a full-width porch with a rusticated concrete block foundation, square columns, open wooden rail, bracketed pent, and a pediment above the entry bay. The entrance door is located in the north bay and a triple window grouping is set in the south bay. Exterior wall fabric is clapboard. Fenestration is one-over-one, double-hung wood sash. The gable end features cornice returns, a triple window grouping with pent and wood shingles sheath the gable peak. The south elevation has a side entrance with awning. Extending east from the east end of the main block is a one-story, gabled-roof addition. A gabled dormer rests on the south slope and a brick chimney rests on the center ridge.
