6. STATE STREET

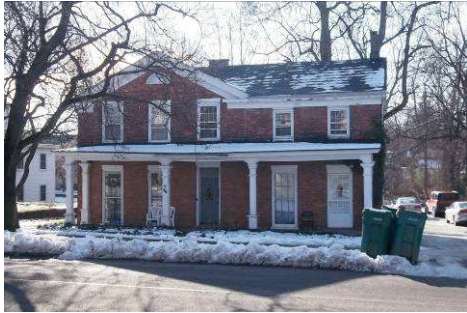
<p>ADDRESS: 46 State Street</p>	<p>TAX ID: 069.53-2-6</p>	<p>DATE OF CONSTRUCTION: Ca. 1850s</p>	<p>SIGNIFICANCE: D – Contributes to potential NR district; Designated local landmark</p>
<p>CONDITION: Fair</p>		<p>NAME: William Henry Bull House</p>

<p>DESCRIPTION: 2-story cross-gable brick house with modest Italianate styling; sandstone foundation, asphalt shingle roof. Full width open entry porch with decorative square wood supports, two separate entry doors. Windows typically 6/6 wood sash double hung, taller at first floor. Includes rear concrete block addition. USN 05541.000021</p>	
<p>ADDRESS: 52 State Street</p>	<p>TAX ID: 069.53-2-7</p>	<p>DATE OF CONSTRUCTION: Ca. 1850s</p>	<p>SIGNIFICANCE: D – Contributes to potential NR district</p>
<p>CONDITION: Good</p>		<p>NAME: Enoch Sweat House</p>

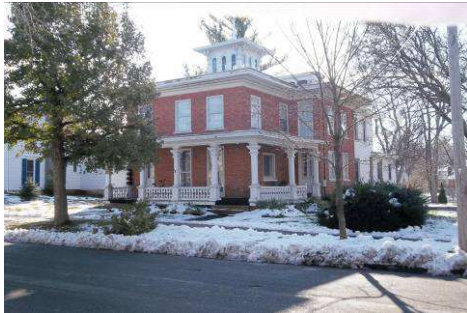
<p>DESCRIPTION: 2 ½-story hipped roof brick house with Italianate styling; asphalt shingle roof. Full width wrap around open entry porch with decorative square wooden supports and wooden balustrades, two separate wooden entry doors. Windows typically 6/6 wood sash double hung. Roof features square cupola with three rounded arch 1/1 wood sash double hung windows at each side, bracketed cornice. Large 1- and 2-story additions to east side and rear of main house; concrete block foundation vinyl siding and asphalt shingle roof. USN 05541.00023</p>

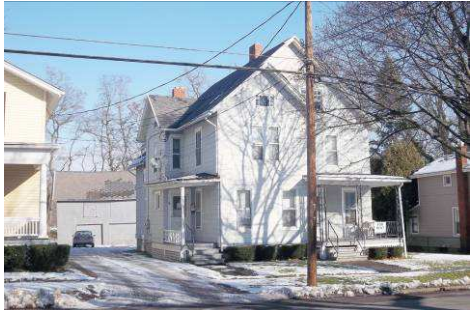
ADDRESS: 97/99 State Street	TAX ID: 069.13-1-14	DATE OF CONSTRUCTION: Ca. 1895	SIGNIFICANCE: D – Contributes to potential NR district
CONDITION: Fair		NAME:

DESCRIPTION: 2 ½-story multiple front-gable frame house with modest Queen Anne styling; field stone foundation, asbestos siding, asphalt shingle roof. Half width open entry porch with metal supports and balustrades. Windows typically 1/1 wood sash double hung with irregular fenestration. Smaller gable end features multi-lite wood window and larger gable features paired 4/1 wood windows. West side elevation features single bay recessed entry porch with spindlework support and wood balustrades. Property includes contributing large 2-story side-gable wooden barn. USN 05541.000432	
ADDRESS: 100 State Street	TAX ID: 069.13-2-6	DATE OF CONSTRUCTION: Ca 1870s	SIGNIFICANCE: D – Contributes to potential NR district
CONDITION: Good		NAME:

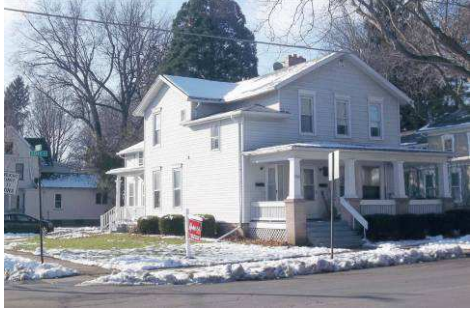
DESCRIPTION: 2-story cross-gable frame vernacular house with Craftsman style porch; sandstone foundation, vinyl siding, asphalt shingle roof. Full width open entry porch with battered wood columns atop brick piers, wood balustrades, two separate entry doors. Windows typically 1/1 replacement window units with flat hoodmolds, bay window at first story. Secondary porch at east side elevation with decorative square wooden Italianate columns and wood balustrades. USN 05541.000437

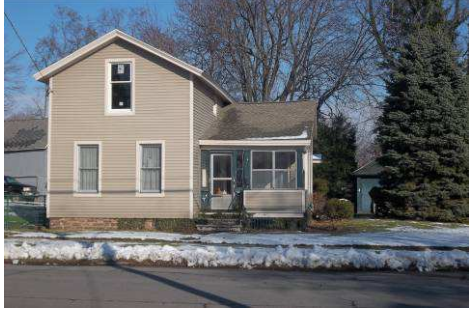
<p>ADDRESS: 103 State Street</p>	<p>TAX ID: 069.13-1-15</p>	<p>DATE OF CONSTRUCTION: Ca. 1870s</p>	<p>SIGNIFICANCE: N – Significantly altered; does not contribute to potential NR district</p>
<p>CONDITION: Fair</p>		<p>NAME:</p>

<p>DESCRIPTION: 1 1/2-story front-gable with wing frame vernacular house; field stone foundation, vinyl siding, asphalt shingle roof. Half width enclosed entry porch with square wooden pilasters, contemporary entry door. Windows typically 1/1 replacement units. Property includes non-contributing hipped roof garage. USN 05541.000433</p>	
<p>ADDRESS: 108 State Street</p>	<p>TAX ID: 069.13-3-1</p>	<p>DATE OF CONSTRUCTION: Ca. 1870s</p>	<p>SIGNIFICANCE: D – Contributes to potential NR district; Designated local landmark</p>
<p>CONDITION: Excellent</p>		<p>NAME:</p>

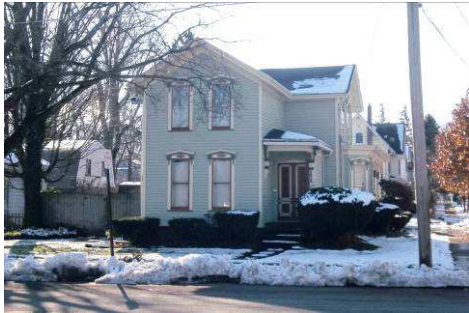
<p>DESCRIPTION: 2-story cross-gable frame house with Italianate styling; sandstone foundation, wood clapboard siding, asphalt shingle roof. Recessed open entry porch with decorative wooden brackets and metal support, historic wood panel double entry door. Windows typically 1/1 wood sash double hung with wooden storm windows and wooden window frames topped with a bracketed decorative pediment. West side elevation features bay window and porch with spindlework supports and wood balustrade. USN 05541.000311</p>

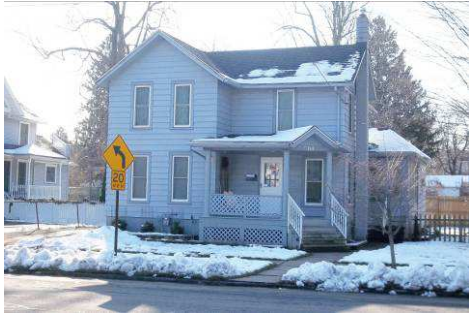
<p>ADDRESS: 114 State Street</p>	<p>TAX ID: 069.13-3-2</p>	<p>DATE OF CONSTRUCTION: Ca. 1870s</p>	<p>SIGNIFICANCE: D – Contributes to potential NR district; Designated local landmark</p>
<p>CONDITION: Good</p>		<p>NAME:</p>

<p>DESCRIPTION: 2-story cross-gable frame vernacular house; parged foundation, aluminum siding, asphalt shingle roof. Half width open entry porch with pediment at corner, round wooden columns. Windows typically 1/1 replacement units. Property includes contributing single-bay front-gable garage. USN 05541.000438</p>

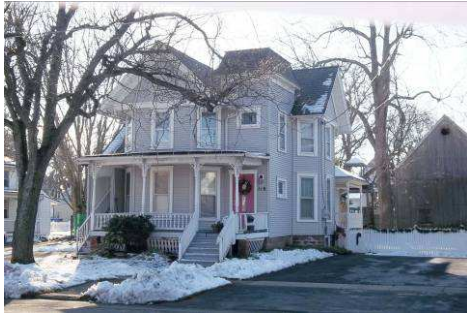
ADDRESS: 118 State Street	TAX ID: 069.13-3-3	DATE OF CONSTRUCTION: Ca 1870s	SIGNIFICANCE: D – Contributes to potential NR district
CONDITION: Good		NAME:

DESCRIPTION: 2 ½-story cross-gable with mansard roof tower frame house with Queen Anne styling; sandstone foundation, vinyl siding, asphalt shingle roof. Nearly full width open entry porch with spindlework supports and balustrades, decorative brackets, wooden entry door. Windows typically 1/1 wood sash double hung, some leaded glass casement windows. Includes two story cutaway bay windows at front and west side elevations. Gable ends feature fish scale shingle siding. Porch with spindlework supports and balustrades at west side elevation. Enclosed stair to second story at east elevation. Property includes contributing large front-gable wooden barn. USN 05541.000312	
ADDRESS: 124 State Street	TAX ID: 069.13-3-4	DATE OF CONSTRUCTION: 1858	SIGNIFICANCE: N – Significantly altered; does not contribute to potential NR district

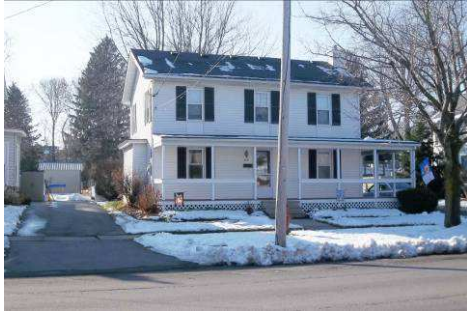
CONDITION: Good		NAME:

DESCRIPTION: 2-story side-gable frame Colonial Revival house; vinyl siding, asphalt shingle roof. Full width wrap around open entry porch with wood supports and railings, wooden entry door. Windows typically 1/1 replacement units. Property includes non-contributing side-gable metal garage. USN 05541.000436
